Removal of severe rolling contact fatigue (RCF) defects by means of a heavy corrective rail grinding intervention: experience gained in practice

By: Dr. Wolfgang Schöch, Director External Affairs & Alexander Baltzewitsch, Applications Manager, Speno International SA, Switzerland.

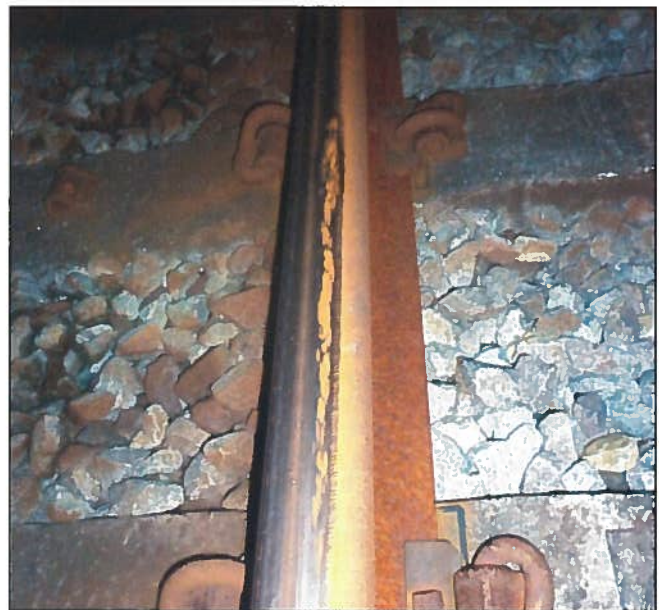
Fig. 1: Advanced centre-line spalling

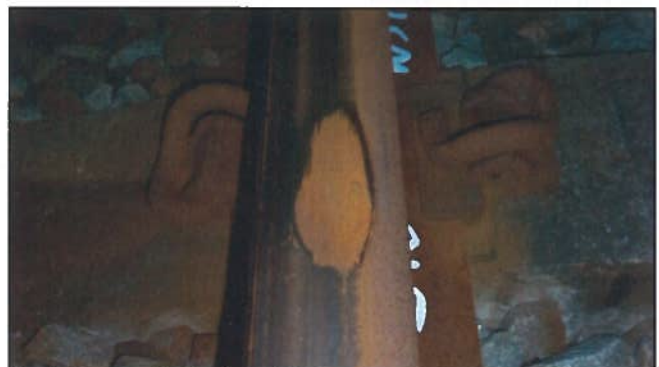
Fig. 2: Deep spalling in the rail head centre

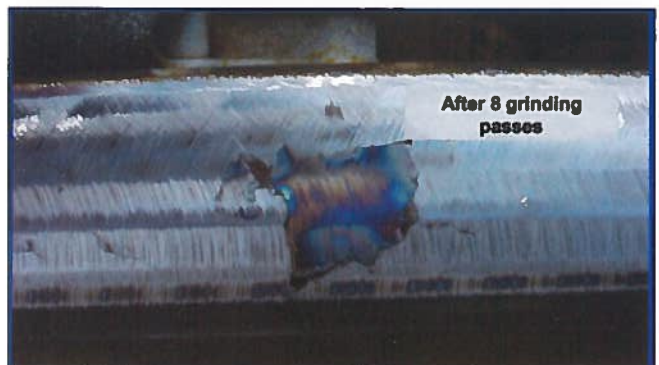
Fig. 3: Appearance of a squat-like defect during grinding

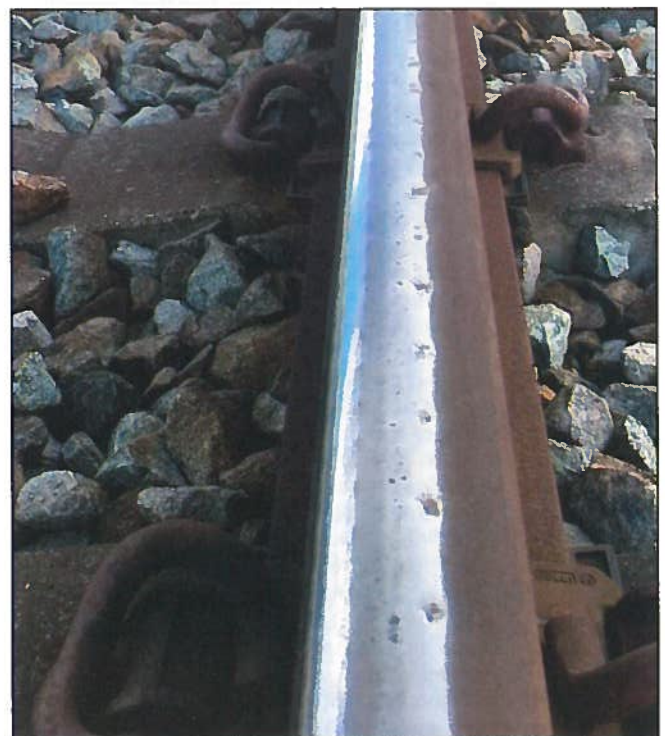
A heavy corrective grinding intervention was conducted to remove severe rail surface defects by using a 64-stone grinding machine, which has confirmed its positive effect. In Fig. 4, an example of a severe rail defect that was found in the track section concerned is shown.

Fig. 4: Severe status of rail defect prior to grinding

Ultrasonic measurements of the rail concerned yielded that the amount of metal that had to be removed would be 6 mm, as measured from top of rail. The machine used for the grinding intervention was a Speno RR 64 M-2, a heavy-duty 64-stone grinding machine. By using the grinding simulation model developed by Speno International SA, it was calculated that the grinding work would require 12 passes at a speed of 5 km/h, which translates into an average metal removal rate of 0.5 mm per pass. Only a single grinding pattern covering the full rail head width from 70° gauge side to 5° field side was designed, thus ensuring an equal amount of metal removal over the entire specified area, allowing the grinding work to be interrupted whenever needed for operational reasons.

According to plan, the aforementioned 12 passes were executed during a single night shift. Prior to grinding and after every pass, measurements were carried out, using Miniprof, at four different locations. At the same time, the surface crack situation on the high rail was checked by using a manually-pushed eddy-current measuring trolley. Ultrasonic measurements conducted locally, pass-by-pass, recorded the defect reduction progress.

Following the final grinding pass, all defects were completely removed! The amount of metal removed corresponded perfectly to the values calculated by the simulation model, which took into account the deployment of high-performance grinding stones.

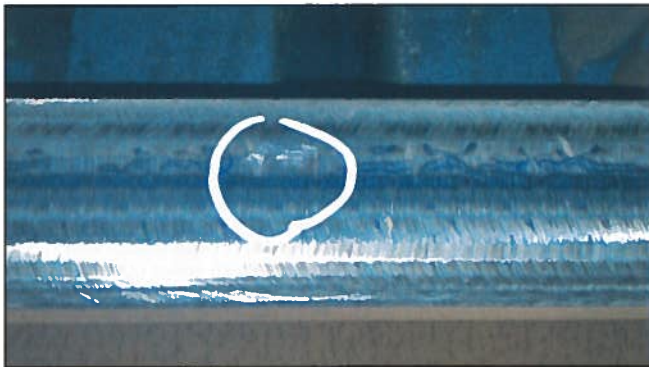
Fig. 5: Status following the removal of 3.5 mm of metal

In Figs. 5, 6 and 7, respectively, the rail surface after 3.5 mm and 6 mm of metal removal, and following completion of the finish grinding, are shown. The pass-by-pass changes in transverse profile are shown in Figs. 8a and 8b.

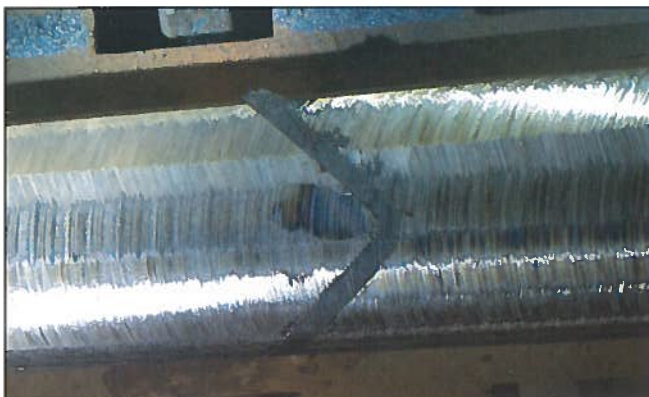
Fig. 6: Status following the removal of 6 mm of metal

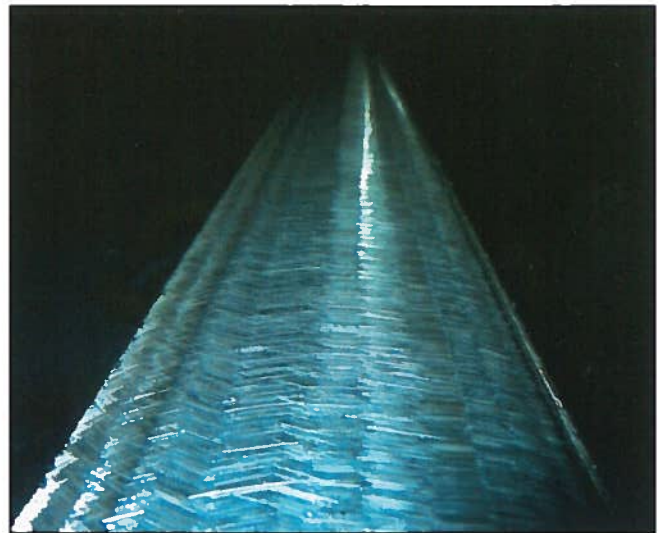
Fig. 7: Finished ground rail

Finally, two finishing passes with a high grinding speed of 16 km/h were executed, in order to achieve the low level of rail surface roughness required for the specific line, in view of its location in a noise-sensitive area – upon completion, a surface roughness R_a of about 2 microns was measured.

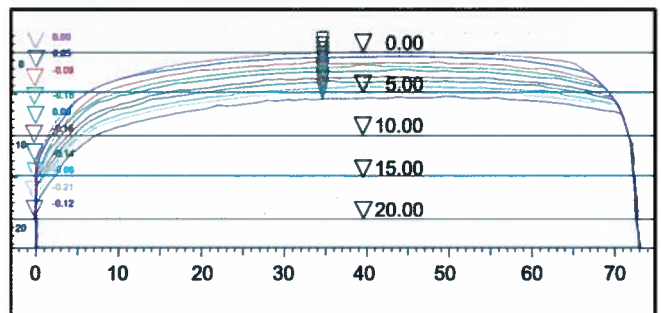
Fig. 8a: Metal removal – profile prior to grinding, and following grinding passes 1-9

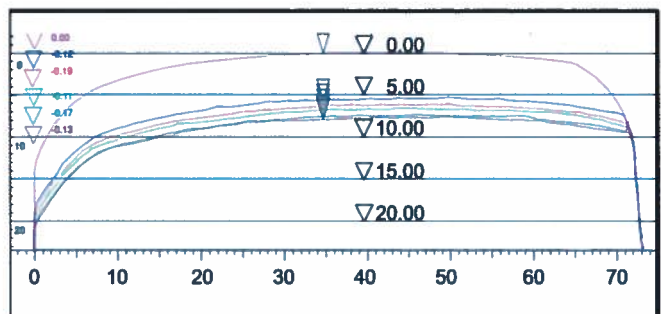
Fig. 8b: Metal removal – profile prior to grinding, and following grinding passes 9-12, 14

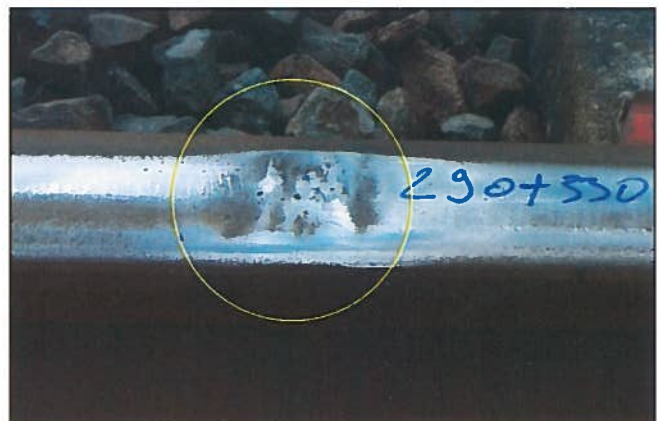
Fig. 9a: Squat removal – prior to grinding

In another case, squats were removed during a routine grinding program, using a 48-stone grinding machine. In Fig. 9a, the rail surface prior to grinding is shown.

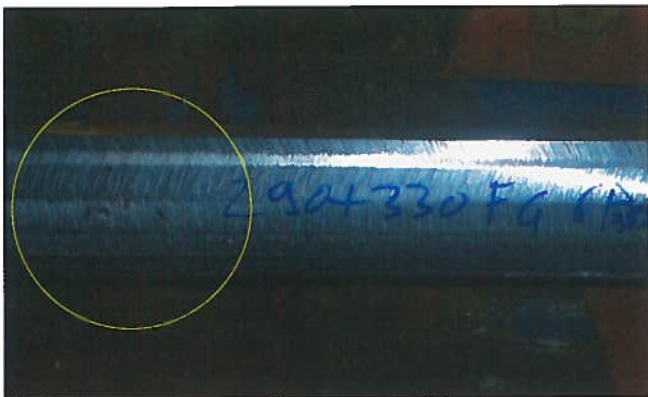
Fig. 9b: Squat removal – after 6 grinding passes

As can be observed in Fig. 9b, after six grinding passes, the longitudinal and transverse rail profile did not exhibit any irregularities. However, as the crack had grown deep into the rail head, additional metal removal was required. Finally, it took 13 passes in total to remove the squat completely – the totally crack-free rail surface is shown in Fig. 9c. In total, 4.5 mm of metal was removed, as can be seen from the profile superposition before and after grinding for the same spot depicted in Fig. 9d.

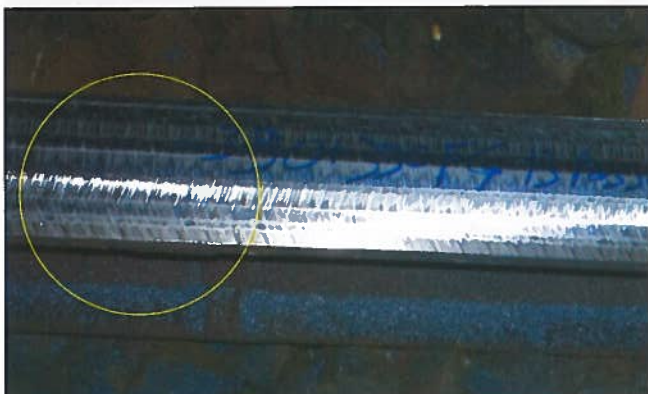
Fig. 9c: Squat removal – after grinding

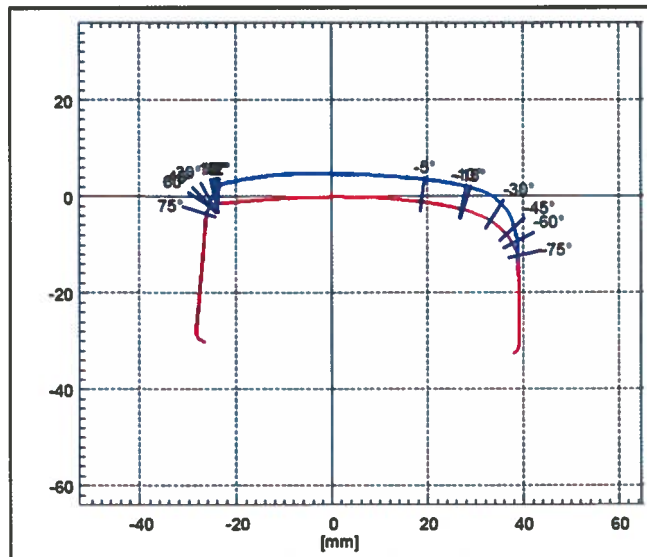
Fig. 9d: Squat treatment – 4.5 mm of metal removal
