RAIL ENGINEERING INTERNATIONAL

Combating rolling contact fatigue: strategies adopted in The Netherlands

Since 2001, ProRail has been actively investigating the causes of rolling contact fatigue (RCF) and, in close collaboration with Netherlands Railways (NS) and NedTrain, has developed strategies to reduce its occurrence. This article looks at the practical approach adopted by ProRail towards managing RCF. First, a short introduction is given of ProRail's track management approach. Then, the dramatic increase in the occurrence of RCF on the Dutch railway network and the countermeasures adopted are addressed.

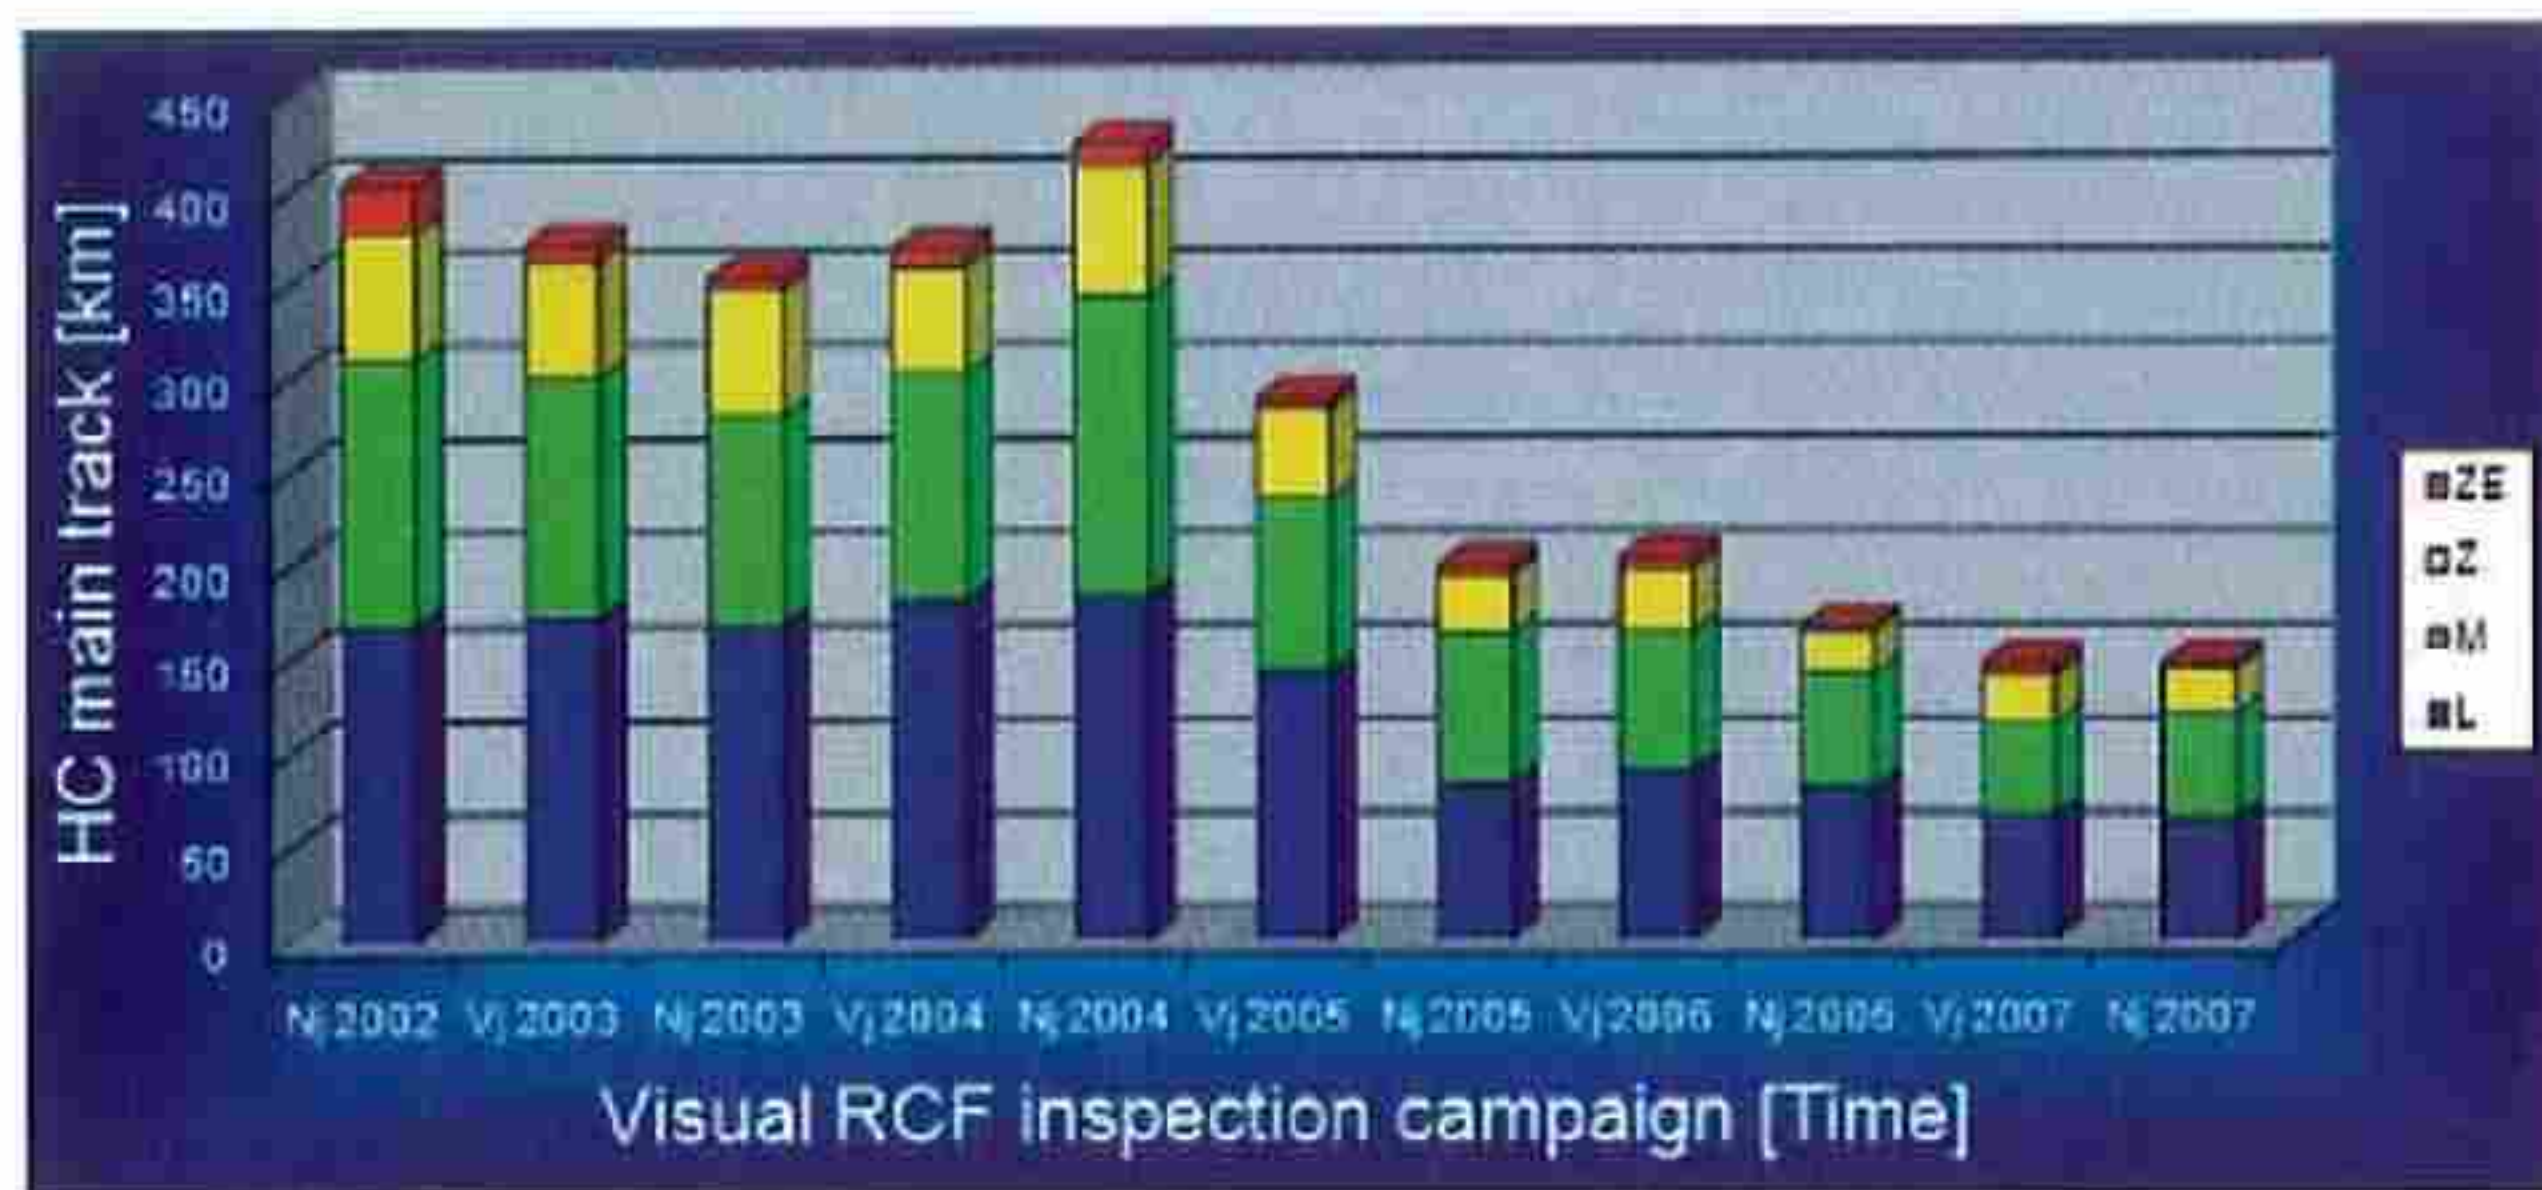
Fig. 5: Reduction in the occurrence of RCF (2000-2007). In The Netherlands, until 2009, RCF inspection campaigns were conducted twice a year (i.e. in the spring "vj" and in the autumn "nj") to determine the presence of headchecks (left) and squats (right) [3]

Improvement of RCF detection has played a significant role in successfully reducing its occurrence in absolute numbers (see Fig. 5). In Fig. 5, also the development in the occurrence of RCF since 2004, when preventative rail grinding was introduced, can be observed.

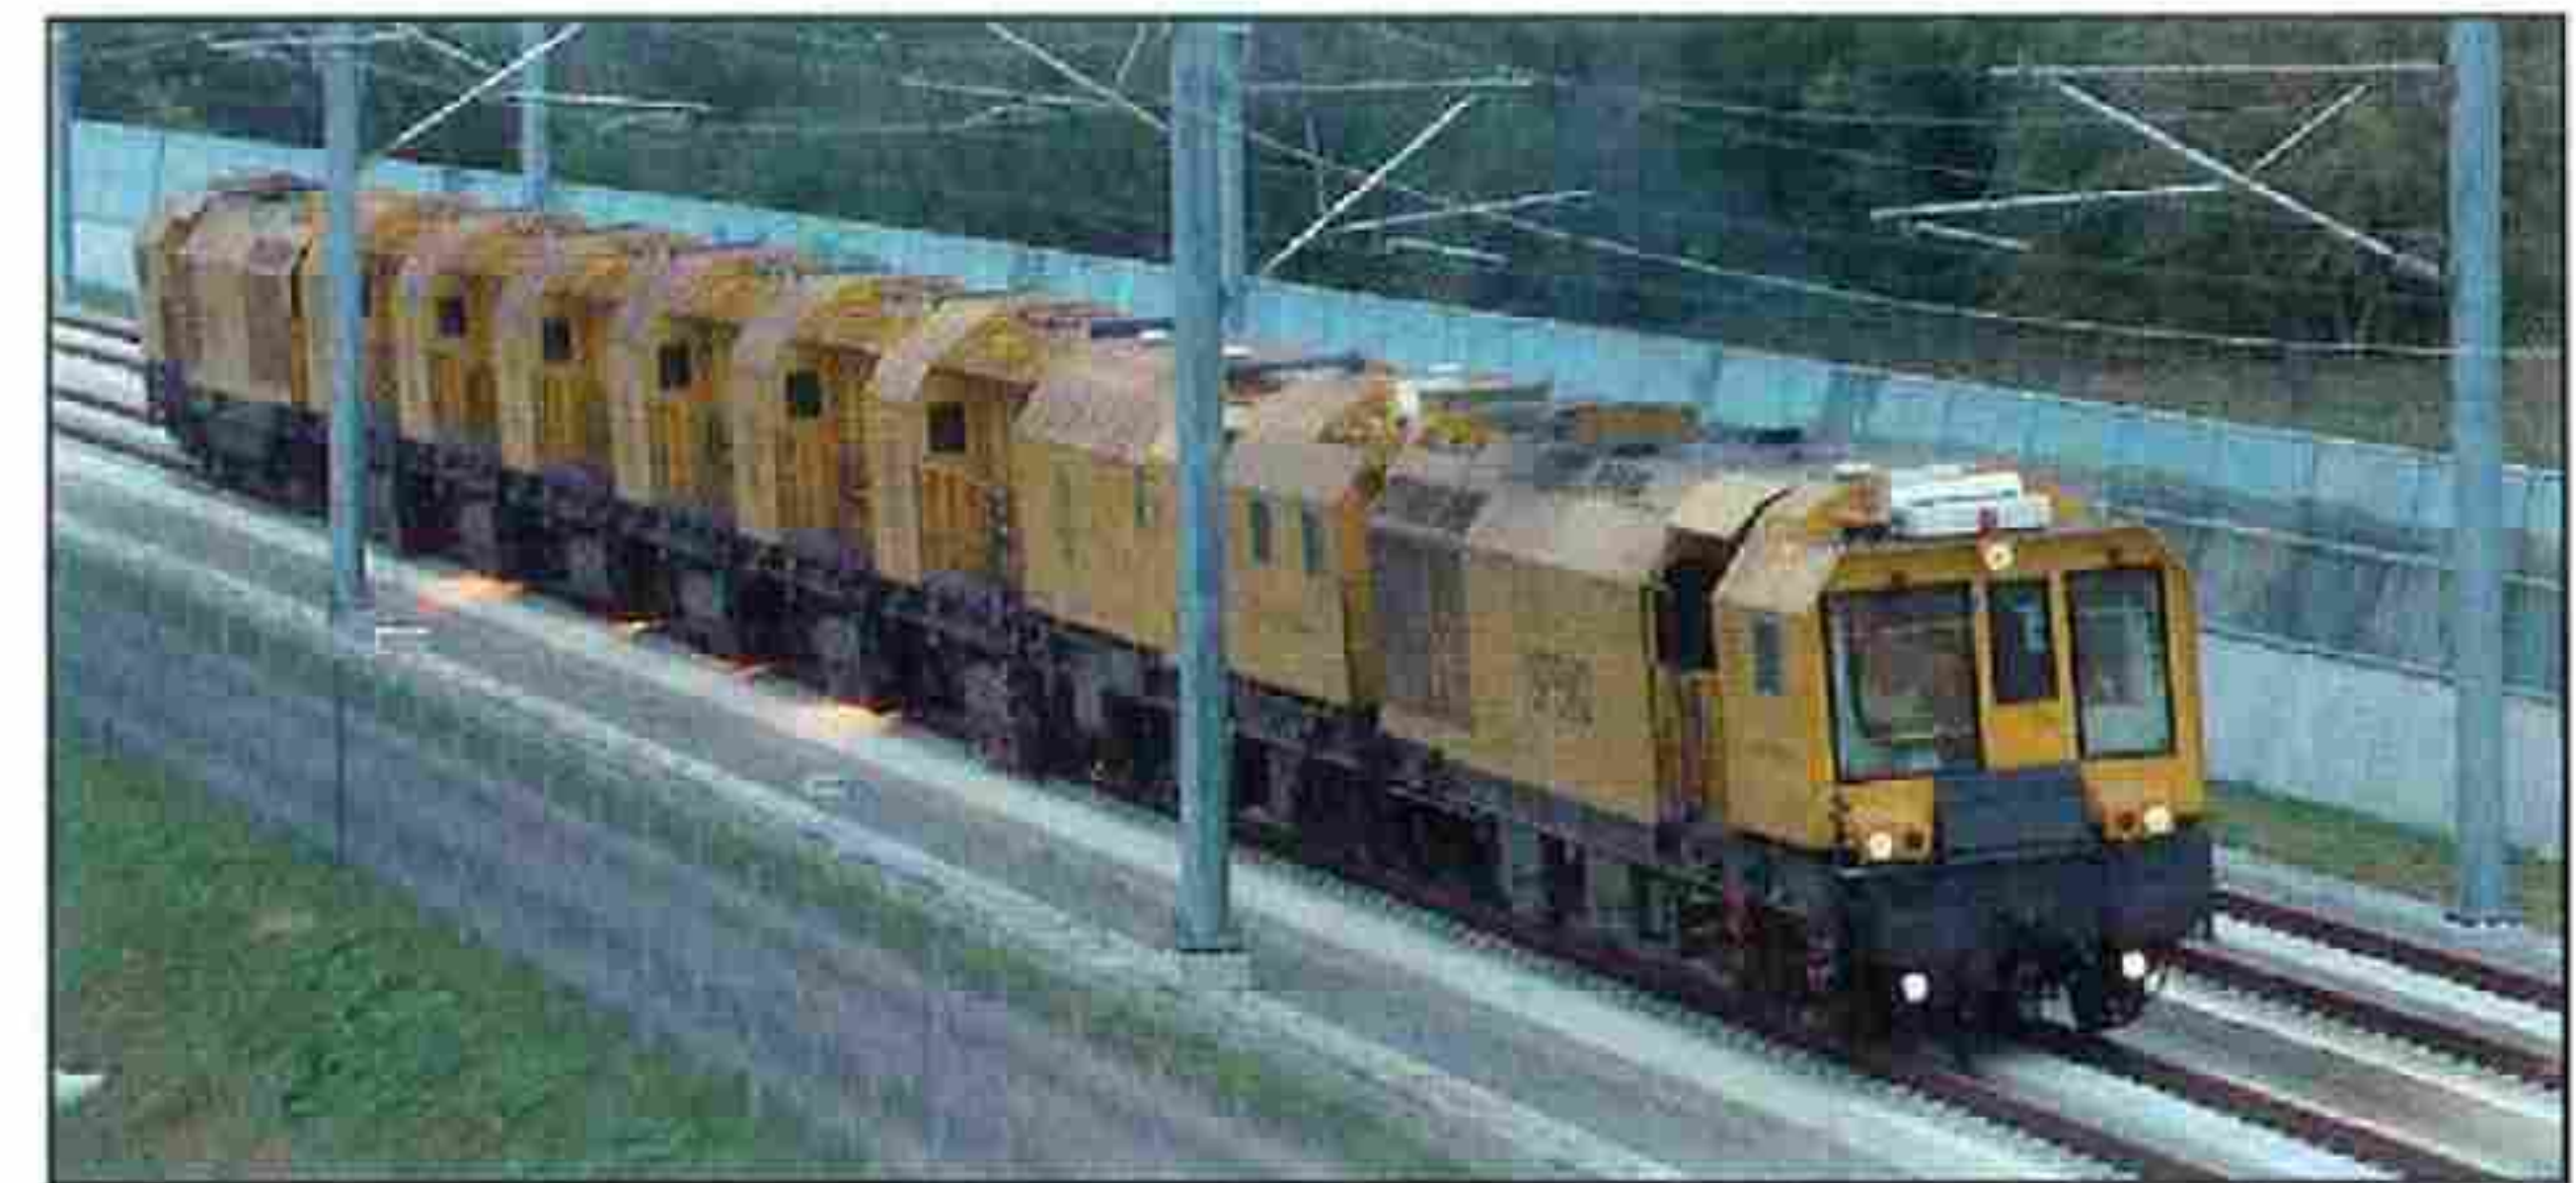
Fig. 6: The implementation of preventative rail grinding in The Netherlands has contributed to a significant reduction in the occurrence of RCF

Implementation of preventative rail grinding (Fig. 6)

In The Netherlands, preventative rail grinding was implemented in 2004 (pilot phase) and 2005 (national roll-out), with different grinding intervals for different loads and curve radii - directly adopted from Canadian heavy-haul practice [5]. It took a number of years to get the entire railway network into a certain basic condition, after which more limited grinding intervals and depths could be adopted, which was the case in 2008. The preventative rail grinding strategy adopted has led to a 75% reduction in the occurrence of the most severe category of headchecks on straight track: i.e. from 25 km affected with severe headchecks in 2002 to 5 km in 2007.
