# Grinding of rails on high-speed railway lines: a matter of great importance

By: Dr. Wolfgang Schöch, Manager External Affairs, Speno International SA, Geneva, Switzerland.

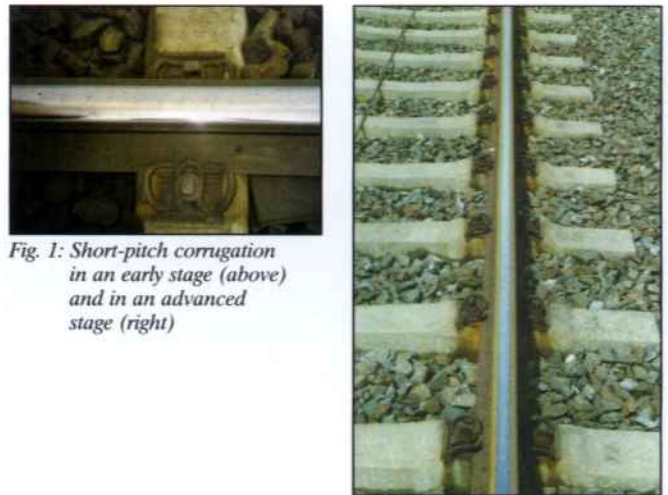
Fig. 1: Short-pitch corrugation in an early stage (above) and in an advanced stage (right)

The specific layout of high-speed railway lines means that there are no curves with small radii that might provoke short waves on the low rail. However, short-pitch corrugation can occur in tangent track, particularly in the presence of high track stiffness (Fig. 1). Consequently, heavy concrete sleepers on intensely compacted ballast increase the possibility of corrugation occurrence.

Short-pitch corrugation causes an increase in noise during the passage of trains. At high train speeds, even irregularities of around 0.03 mm in depth can create discomfort for passengers and wayside residents. In Japan, rail grinding is mainly conducted to combat noise. Twice a year, the high-speed railway lines in this country are ground, in order to provide a smooth ride for the “bullet” trains.

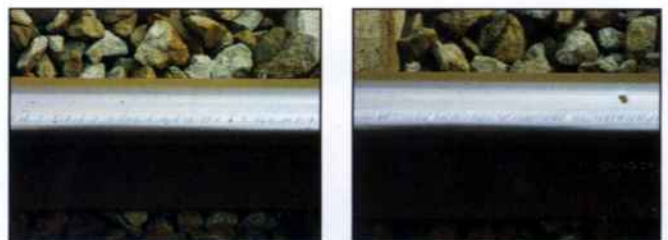
Fig. 2: Headchecks at gauge corner, widely spaced (left) and densely spaced with single ballast stone imprint (right)

In shallow curves, the high rails are particularly prone to rail surface fatigue in the form of fine hairline surface cracks, so-called headchecks, due to consistent wheel/rail contact in a fairly small zone close to the gauge corner (Fig. 2).

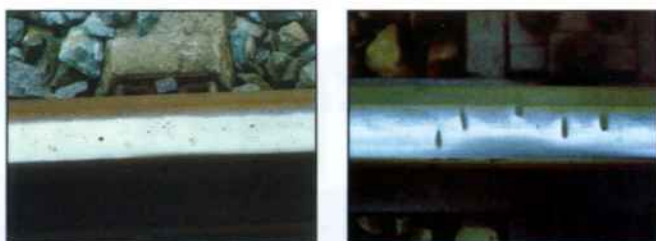
Fig. 5: Ballast stone imprints, small (left) and medium (right)

Some high-speed railway lines suffer from imprints on the rail surface. Trains passing at very high speeds cause air turbulence around and underneath the carriages. Ballast stones are sucked up. If these fall on the rail surface in front of a passing wheel they are crushed into the rail surface, leaving ballast stone imprints of varying depths (Fig. 5). Particularly sensitive to this phenomenon are areas around underpasses and cuttings. In wintertime, rail surface imprints may be due to accumulated ice falling from carriages when approaching warmer areas.

The rail surface imprints act like short-pitch corrugation, causing high levels of vibration and dynamic force. Usually, the rail surface imprints are up to 0.3 mm deep, though some are as deep as 0.5 mm. In order to avoid negative consequences, rail surface imprints are removed by annual grinding campaigns; usual metal removal requirement being 0.3 mm. In this way, a majority of the imprints is eliminated and the larger ones remaining are reduced to an acceptable depth until they are eliminated during the next grinding campaign.

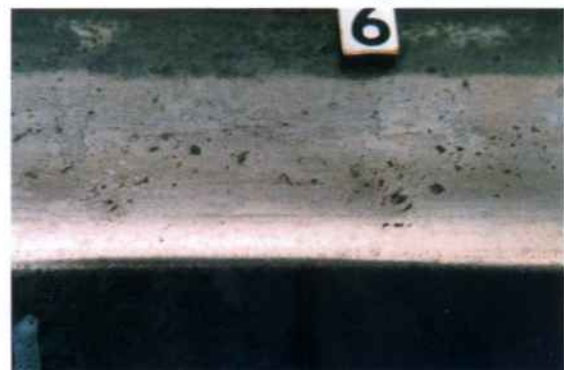
Fig. 6: Example of Belgrospi's

- **Belgrospi's**: on rails affected by short-pitch corrugation, another rail surface fatigue phenomenon has been observed. On the crests, a network of cracks appears, a sort of mixture of irregular headchecks and small squats, with the risk of subsequent severe damage. First detected on a high-speed railway line in Germany by three engineers, named Belz, Grohmann and Spiegel, these are known as “Belgrospi's” (Fig. 6). It has been found that 0.03 mm deep short-pitch corrugation can increase the dynamic forces sufficiently to result in this kind of rail surface fatigue phenomenon.
